# Kilmarnock Watershed Assessment Report

April 2013

**PREPARED FOR:**  
Town of Kilmarnock, VA

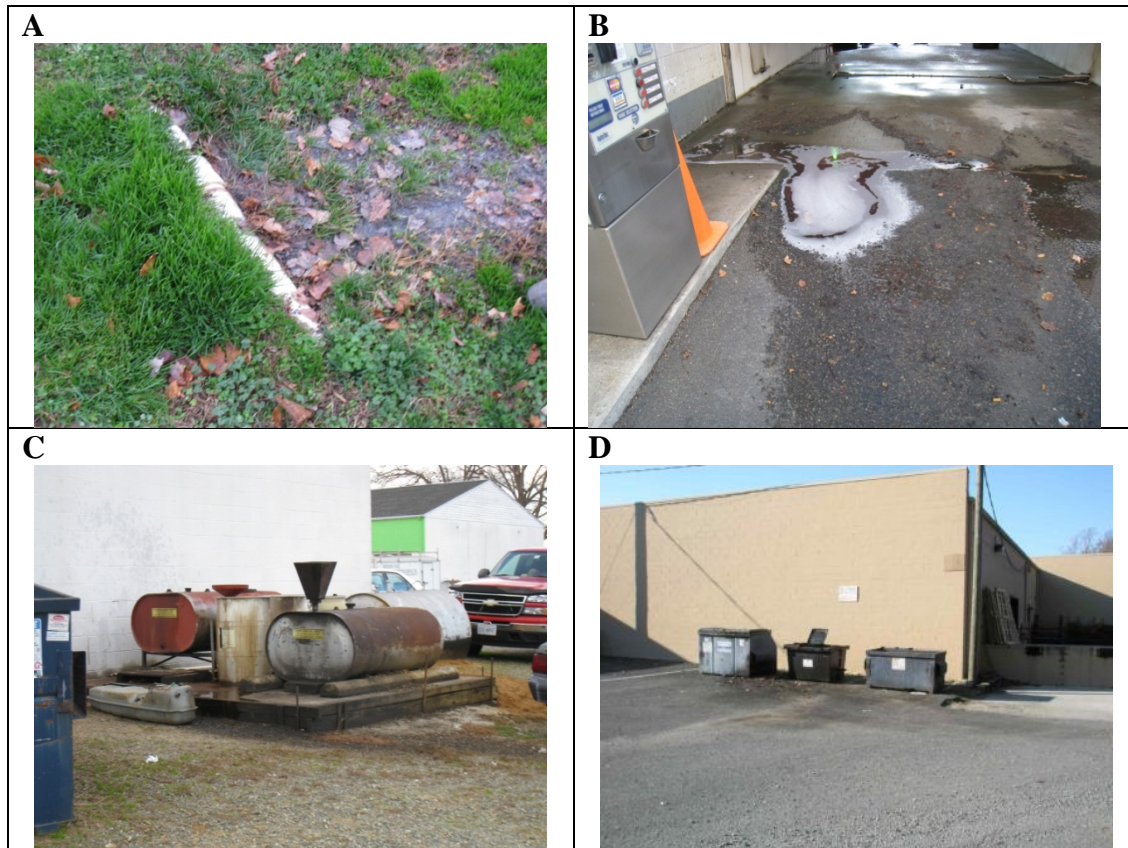
**Figure 6. Pollution producing behaviors found during the HSI: A. Leaking sewer lateral pipe; B. Car wash soapy water draining to parking lot; C. Fuel oil containers overflowing; D. Grease and trash containers leaking onto pavement.**

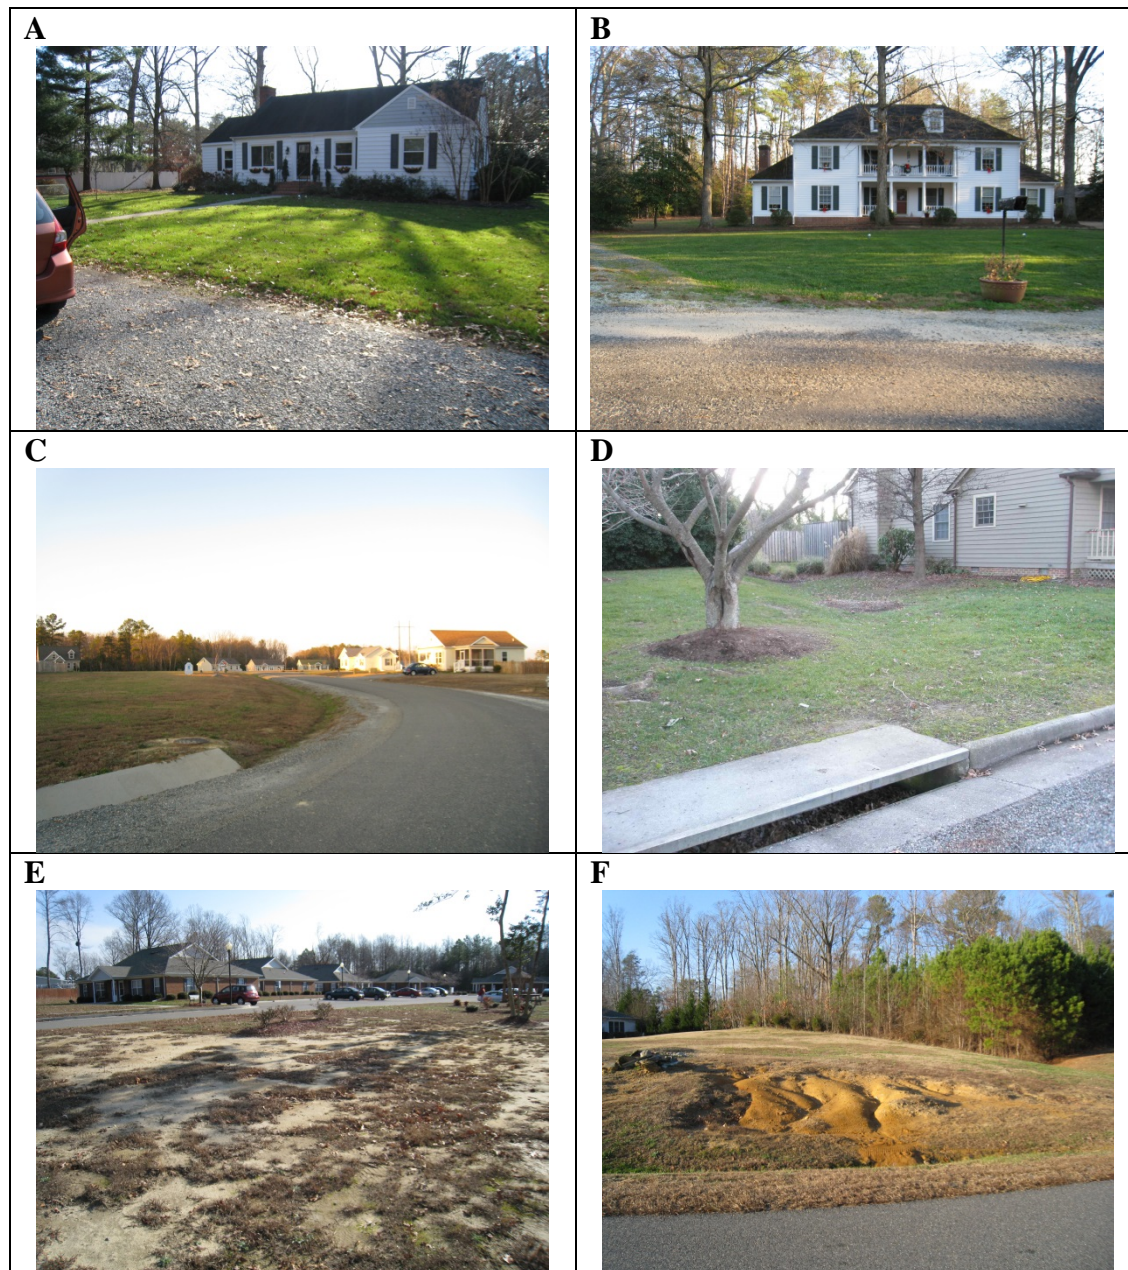
**Figure 8. Examples of neighborhood conditions: A & B. Heavy fertilizer use (Sites N-103 & N-111); C. Lack of trees (Site N-121); D. Opportunity for rain garden (Site N-106); E. Establish better topsoil, plant trees and ground cover (Site N-113); F. Control erosion and reduce mowing, plant trees (Site N-112).**

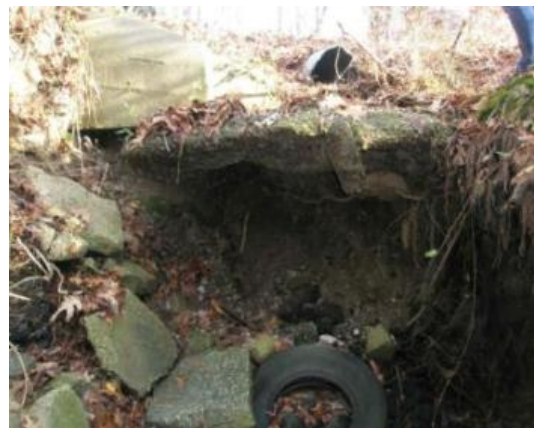
**Figure 10. Head cut S-401**

The most immediate impact to infrastructure is at the Lancaster Middle School (S-401). The outlet of the storm drainage pipe system that drains the visitor entrance driveway, the entire teacher parking lot, and the bus loop discharges into the adjacent woods southwest of the school building. The pipe outlet is suspended above a scour hole more than 5 feet deep and only 6 feet from the edge of the service drive to the School Street Pump Station (Figure 10). The outlet channel meanders through the wooded area and eventually meets the main stream channel.

The geomorphology of this channel includes a clay layer (blue marl, or marlstone, or other very stable clay-based material) that appears to have stopped the down-cutting of the channel at the elevation of the top of the layer. The channel may continue to erode by widening, but the particular geology of this channel appears to be holding the channel geometry relatively constant. Likewise, the head cut has reached the upstream limit (which has been armored with concrete).

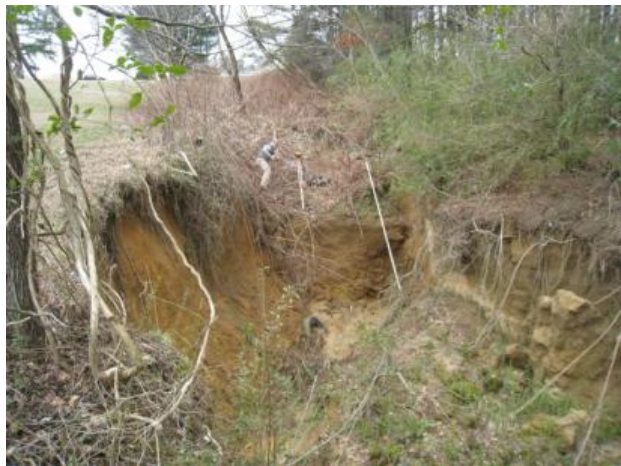
**Figure 11: Head cut S-102**

The head cut initially appears as a sunken area of grass that quickly drops into a gully (eighteen inches wide, two feet deep) with exposed soil on the sides and bottom. It then drops into a large cavernous channel (top width of 13 feet, bottom width of 6 feet, and approximately 6 feet deep) within a channel length of 50 feet (Figure 11). This eroded gully cross section continues to increase in size with sharp grade drops at intermediate locations as the channel erodes from the upper elevation down to the floodplain. Figure 12 shows a schematic profile of the channel as measured in the field.

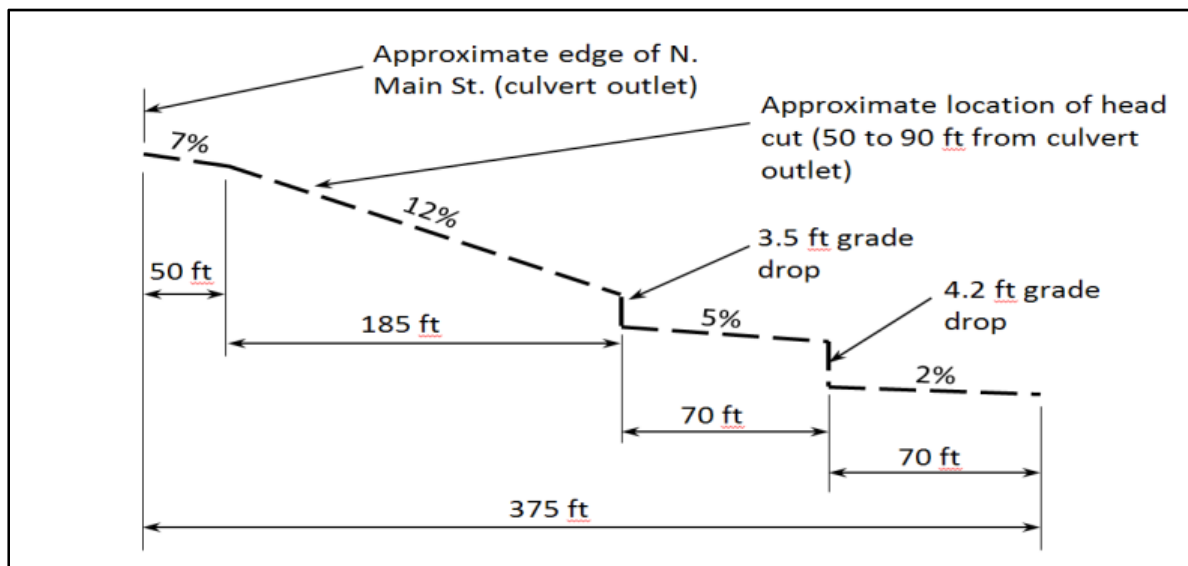
**Figure 12. Schematic profile of head cut S-102**

The profile of head cut S-102 is consistent with the geomorphologic process of a channel eroding and creating a meander to establish equilibrium between the channel grade and the soil structure.

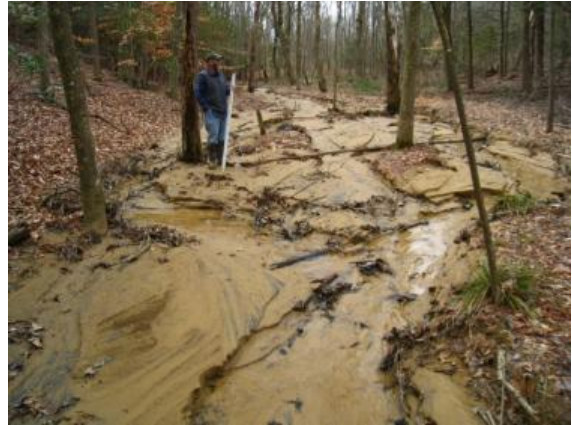
The quantity of sediment scoured from the channel can be approximated from the measured cross sections (approximately 3 ft<sup>2</sup> near the top of the head cut, to approximately 230 ft<sup>2</sup> at the bottom) and the total length of scour above the floodplain. The total length of scour was measured in a straight line, while the actual distance is considerably longer due to the meandering alignment of the erosion process. An inspection of the wide flat floodplain area (approximately 500 feet from the start of the head cut) reveals the stream's base flow braiding through a thick mat of sediment covering the entire width (Figure 13).

**Figure 13: Floodplain below S-102**

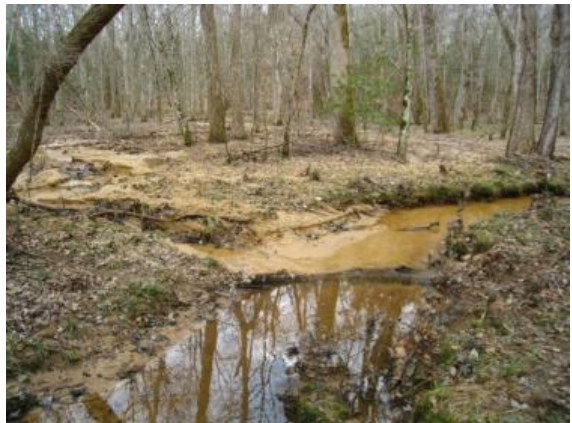
A very rough and conservative estimate is that approximately 1,650 cubic yards of soil has eroded into the floodplain below this outfall channel. Considering an average dump truck hauling capacity of 10 yd<sup>3</sup>, approximately 165 truckloads of sediment from S-102 have covered the flood plain and are slowly migrating towards Norris Pond (Figure 14). Unlike the outfall at S-401 there is no apparent clay layer to slow or limit the channel erosion in terms of the depth of the scour. The channel bottom may continue to down-cut with additional grade drops, the channel width may increase as the meander pushes against the near vertical side walls, and the upstream edge of the head cut will undoubtedly continue to migrate up-gradient. The amount of time before the head cut erosion reaches the edge of North Main Street is dependent on the amount and intensity of rainfall.

**Figure 14: Sediment from S-102 fills downstream channel**

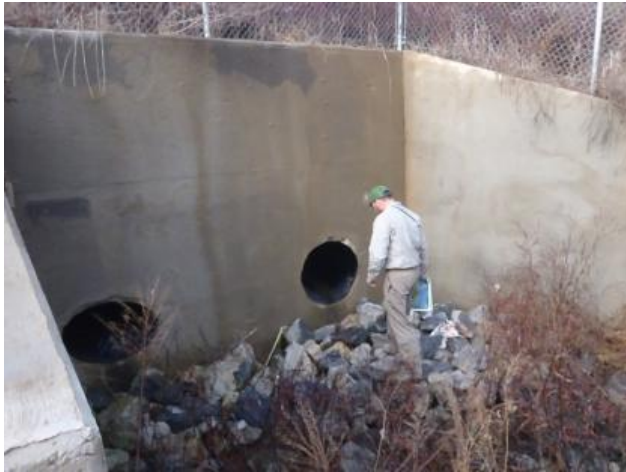
**Figure 15: Concrete headwall above S-103**

The head cut in the outfall channel at S-103 is similarly moving upstream. Although the head cut is not visible from Old Fairgrounds Way, there is evidence of soil instability and erosion in the vicinity of the Old Fairgrounds Way concrete retaining wall and the adjacent drainage system headwall (Figure 15). The overall condition of this head cut is very similar to that of S-102. A quick investigation of the downstream edge of the floodplain (where the outfall channel meets the main channel) as observed from the terminal point of the Baylor Park Nature Trail may indicate that the total volume of sediment that has moved downstream into the floodplain is greater than

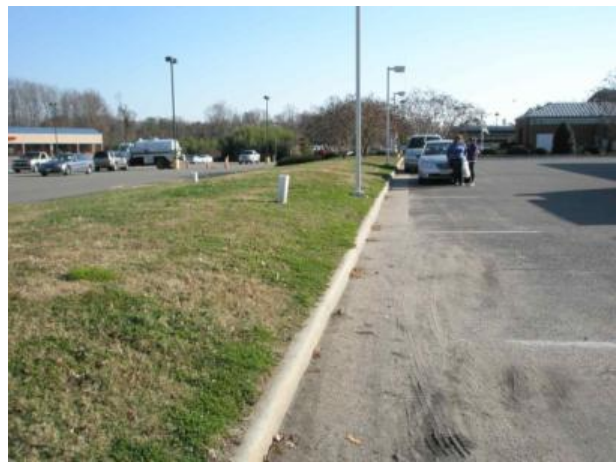
**Figure 4:** Grass island with vent pipes (there is no record of a BMP being located there).

2. Investigate the existing grass strip and possible BMP on the eastern edge of H-105. This strip divides H-105 from the H-121 shopping center parking lot). This appears to be an ideal location for a dry swale or other linear BMP. However, there appears to be an existing underground structure. The outlet pipe from an existing curb inlet appears to go directly into the grass island, and there is no visible outlet pipe; also, the grass island has two PVC vent pipes protruding from the ground (Figures 3 and 4).

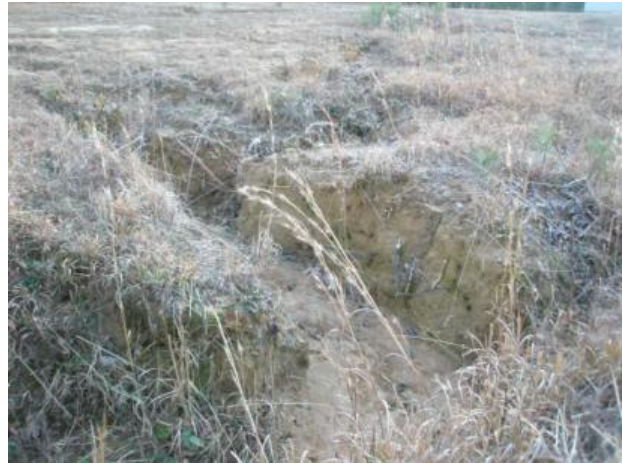
**Figure 2:** Erosion of outlet

**Description:** The Technology Park located off of Harris Road in the Dyer Creek watershed consists of multiple businesses located on individual parcels. Several of the parcels include relatively new water quality BMPs that are functioning well. However, the last business located at the end of Technology Park Drive has an infiltration trench with low earthen berms to convey runoff from the turf and impervious areas of the site to the trench. The turf areas are cut extremely short (it could be described as too short as there is very little “stem density” to the vegetation and evidence of erosion and sediment transport within the turf areas). The trench has a diversion structure that appears to be designed to bypass larger storm flows. However, the accumulation of sediment appears to divert more flow than designed, and the outlet channel is experiencing erosion (Figure 2).

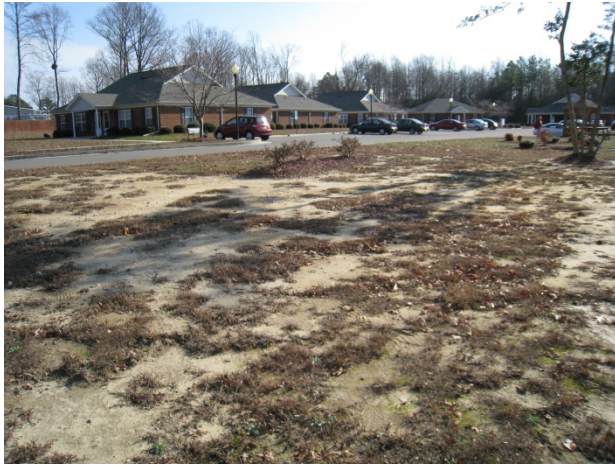
**Figure 1.** Bare soil in communal area

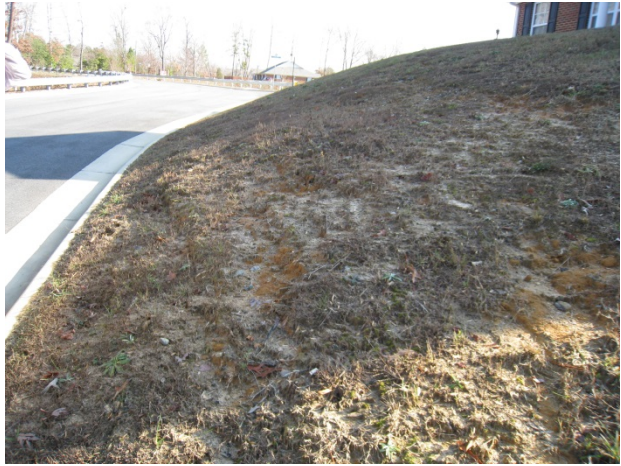
**Figure 2.** Bare, sandy soil on slopes

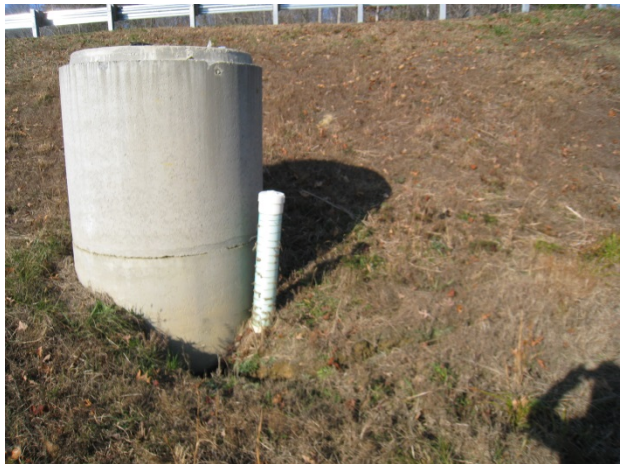
**Figure 4.** Basin outlet, with erosion at base

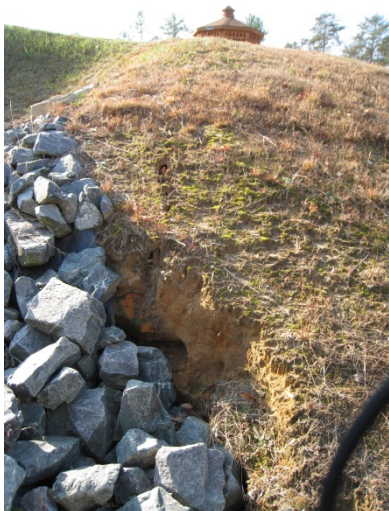
**Figure 5.** Steep basin inlet, eroding

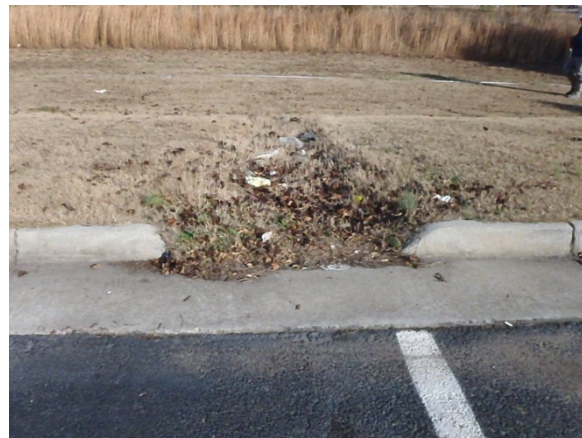
**Figure 3:** Partially clogged inlet to basin

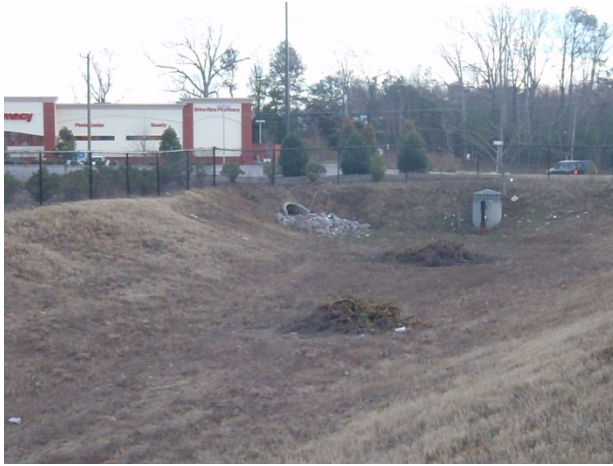
**Figure 1:** Shrub clippings in detention pond

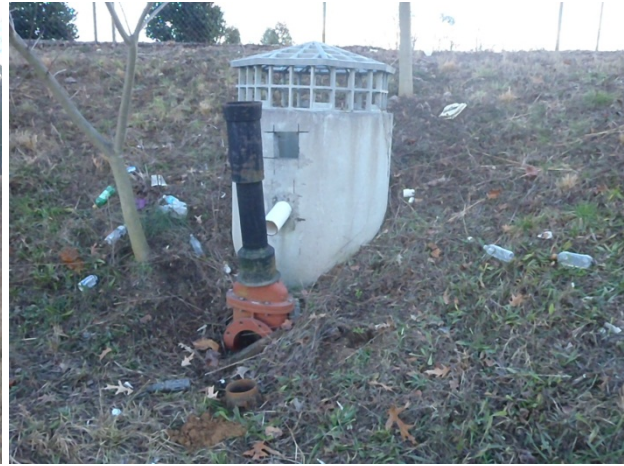
**Figure 2:** Trash around outlet structure

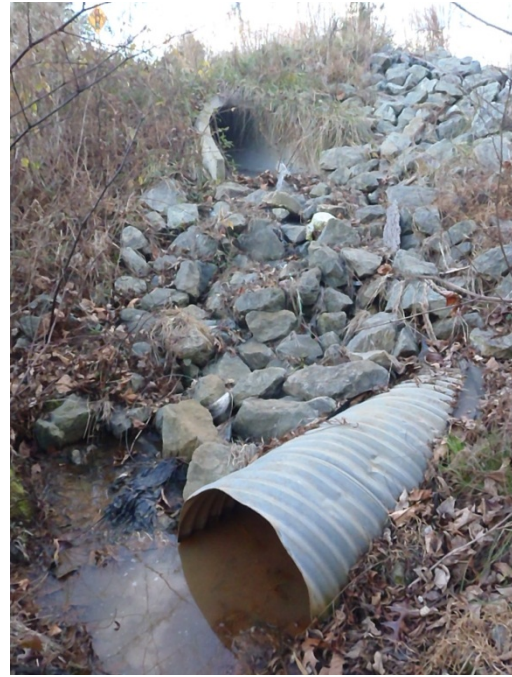
**Figure 2:** Metal outlet pipe partially clogged

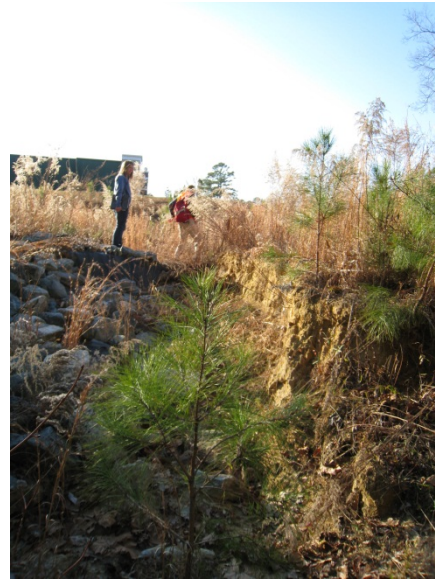
**Figure 2:** Dam section eroded out at spillway

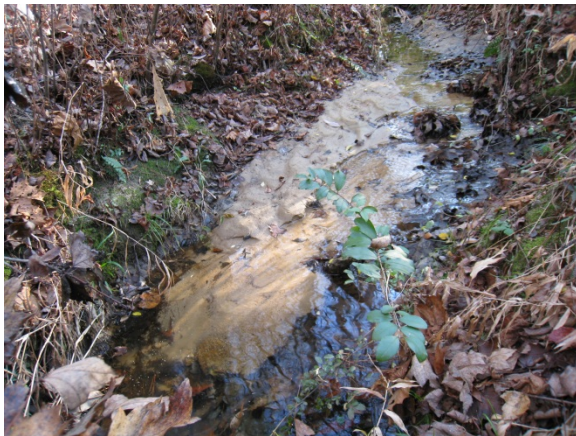
**Figure 3:** Stream filled in by sand from blown out dam

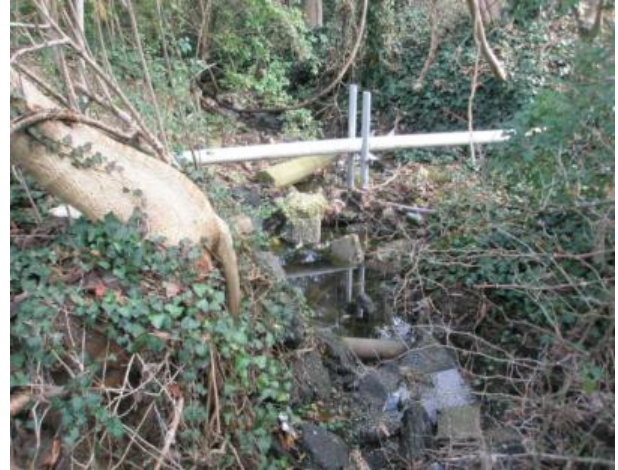
**Figure 1:** Downstream of existing BMP

The Channel downstream of the BMP does not appear to have the significant head cut drops of some of the other channels investigated. However, it could benefit from spot clearing of debris and shaping the channel banks. Also, the sewer connection bracing across the channel should be evaluated for stability and durability since it is very exposed.

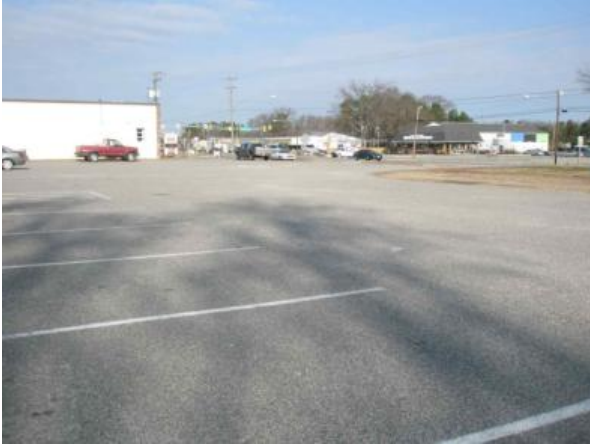
**Figure 3:** Paved area in front of building

2) Remove some pavement in the front parking lot (Figure 3) and either replace it with landscaping or bioretention to promote infiltration, or if the parking areas are needed for events, replace it with permeable pavers in select locations. The paved area in front of the building has only minimal markings for parking, so it is difficult to equate the parking demand with a specific number of spaces. However, utilizing input from the building occupants should allow for a quick assessment of the viability of the options – pavement removal and landscaping, or replacement with permeable pavers.
