# Kilmarnock Watershed Assessment Report

April 2013

**PREPARED FOR:**  
Town of Kilmarnock, VA

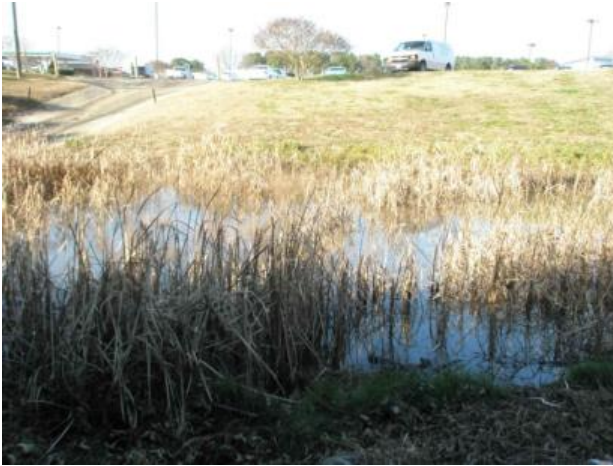
**Figure 1:** Existing stormwater basin

**Description:** Site H-105 is a gas station, H-120 is a McDonald's restaurant, and a third outparcel, a bank, all combine with the main parking lot of the Lancaster Square Shopping Center anchor building, H-121 (Food Lion and several other smaller stores) and drain to an existing stormwater BMP on the southern edge of the parking lot. The BMP is a small basin that could be considered a constructed wetland, extended detention pond with a clogged orifice, or a wet pond with an undersized permanent pool. The site visit noted 3 important observations about the basin:

The repair of the basin should also include some form of pre-treatment at the inflow from the McDonald's site. Ideally, a screen or trash rack keeping the trash in or adjacent to the McDonald's parking lot will be much simpler to maintain than having to access the BMP at the bottom of a hill to remove trash.

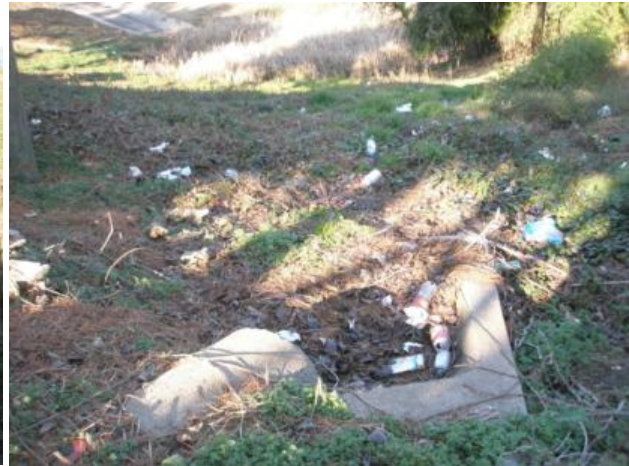
**Figure 1:** Inflow from McDonald's parking lot

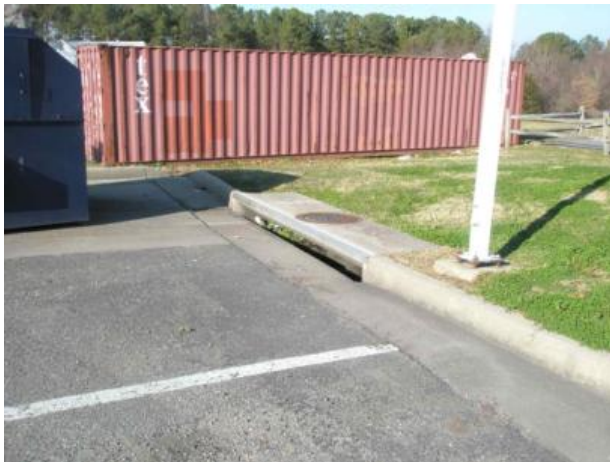
2. Investigate the existing grass strip and possible BMP on the eastern edge of H-105. This strip divides H-105 from the H-121 shopping center parking lot). This appears to be an ideal location for a dry swale or other linear BMP. However, there appears to be an existing underground structure. The outlet pipe from an existing curb inlet appears to go directly into the grass island, and there is no visible outlet pipe; also, the grass island has two PVC vent pipes protruding from the ground (Figures 3 and 4).

**Figure 3:** Curb inlet draining 0.8 ac gas station

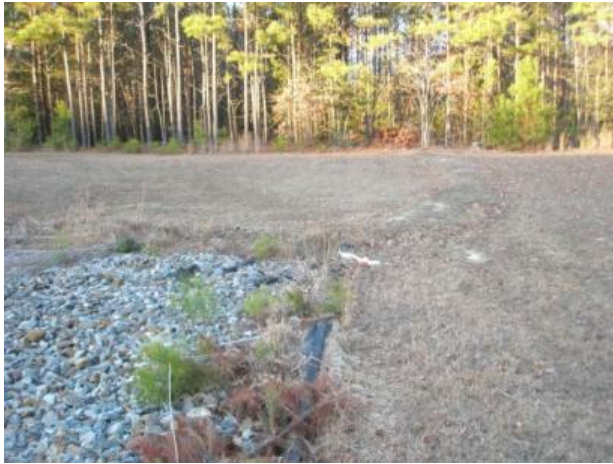
**Figure 1:** Infiltration trench w/ low earthen berm

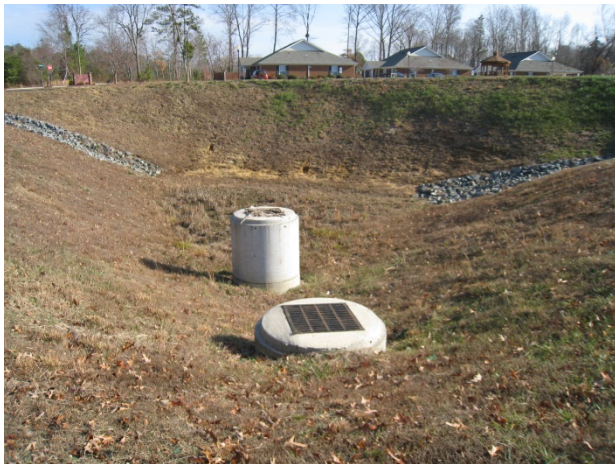
**Figure 3.** Detention basin in communal area

The large detention basin in the central communal area (Figure 3) has some erosion problems, due in part to its steep side slopes, lack of vegetation, and sandy soils. A hole is starting to develop in the ground surrounding the concrete riser structure (Figure 4) and is certain to get worse. And the soil in at least one of the steep rip-rap inlet channels is eroding beneath the stone (Figure 5).

When mowing, set mower deck to high setting to avoid cutting grass too short. Taller grass produces stronger roots, will reduce stormwater runoff from the site, and will expose less soil to erosion. If possible, also try to reduce frequency of mowing to lessen soil compaction over time.

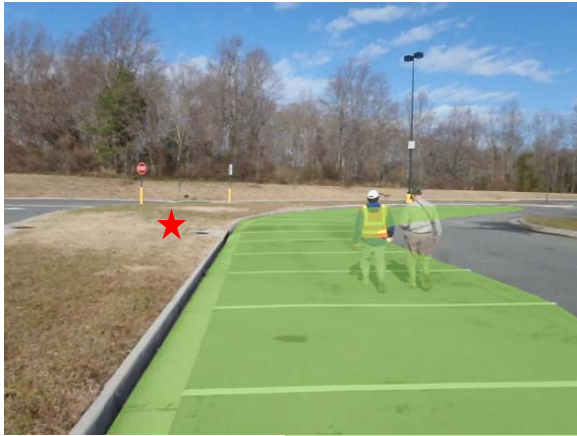
**Figure 1:** Proposed bioretention location in green

**Description:** Most or all of the runoff from the large parking lot and roof at WalMart drains to a wet pond behind the building. There is certainly some water quality treatment benefit to this stormwater management practice, but very little infiltration and groundwater recharge usually occurs in a wet pond. The retrofit proposed here would not only allow better groundwater recharge on the site, but also serve as a highly visible stormwater management and landscaping feature at the entrance of the parking lot.

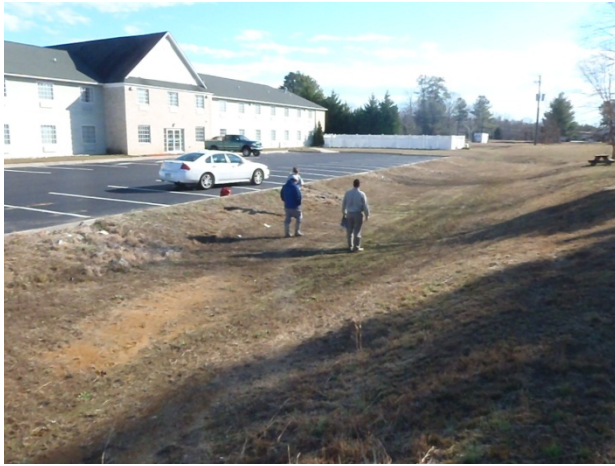
**Figure 1:** Basin behind Holiday Inn

**Description:** The \*detention basin shown in the photos above is located at the back of the parking lot behind the Holiday Inn Express. The surface dimensions of the basin are 29' x 180' and runoff from half of the hotel roof and parking lot enters the basin via several curb inlets. There is a concrete riser-type structure at the northern end of the basin (Figure 2), but it is unclear if and how this structure functions as an overflow outlet. The entire basin is currently managed as grass turf and the soil is very sandy.

More sophisticated retrofit options also exist, including installing pre-treatment forebay cells at the two inlets and retrofitting the bottom of the pond to include multiple ponding areas of different depths. This would increase the flow path between the inlets and the outlet structure and allow for more sediment to drop out of the stormwater before leaving the pond. Figure 3 below shows an example of this type of retrofit design for existing detention ponds.

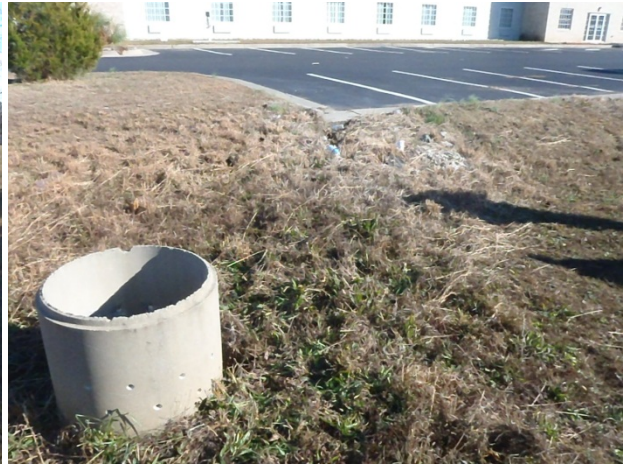
**Figure 2:** Riser structure at northern end of basin

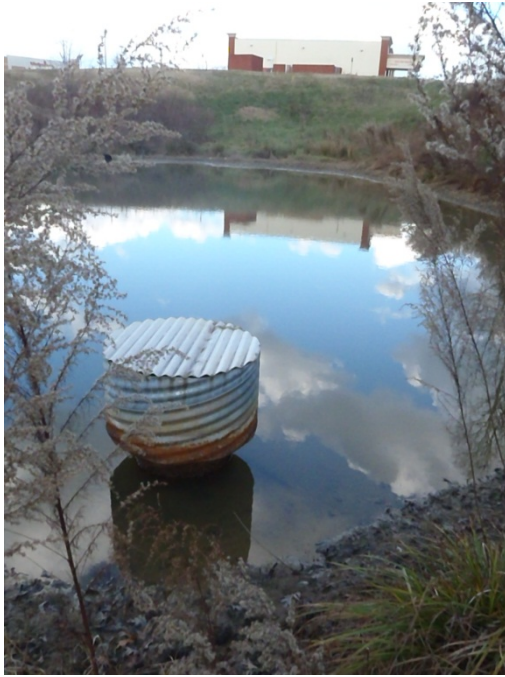
**Figure 1:** Wet pond with metal overflow structure

This pond should be checked annually for any signs of structural failure.

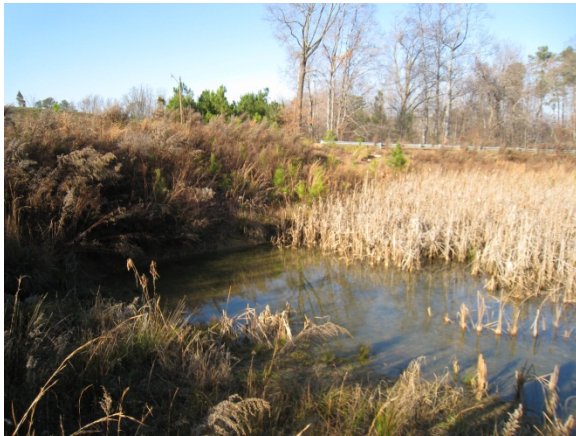
**Figure 1:** Wet pond behind new bowling alley

The pond is located very close to the stream. Caution must be used to not impact the waterway during repairs.

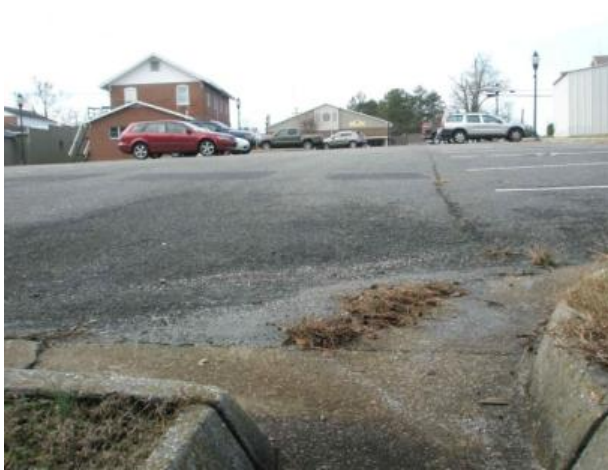
**Figure 1:** Existing drainage from parking lot

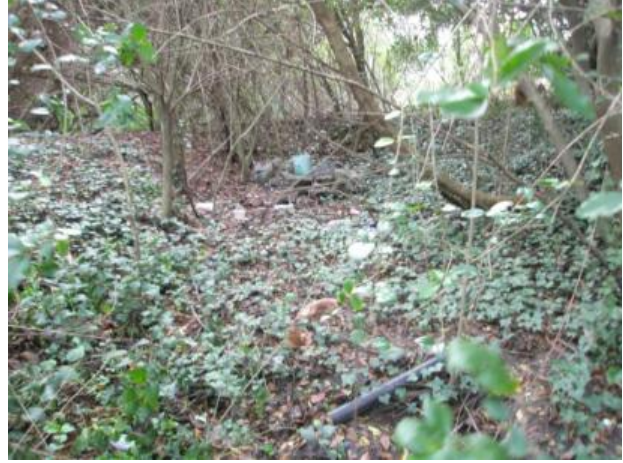
The riser and outlet pipe appear in good condition, although the outlet protection should be restored in conjunction with channel stabilization. (Figure 4)

**Figure 4:** BMP ponding area and riser (blue pipe in background)

The Channel downstream of the BMP does not appear to have the significant head cut drops of some of the other channels investigated. However, it could benefit from spot clearing of debris and shaping the channel banks. Also, the sewer connection bracing across the channel should be evaluated for stability and durability since it is very exposed.

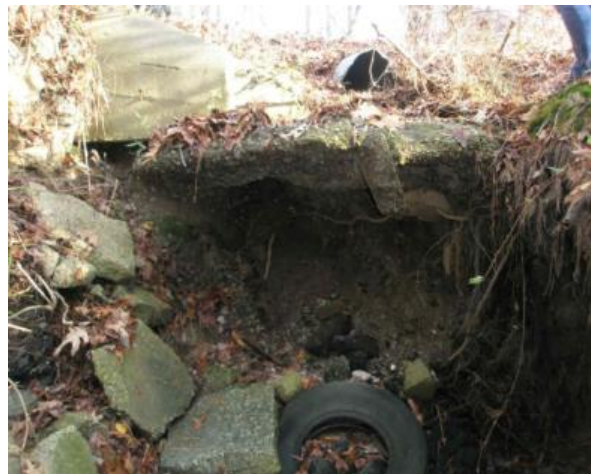
**Figure 1:** Outfall (end section, upper left)

**Description:** The Lancaster Middle School property includes a typical amount of impervious cover: a bus loop (Figure 1), teacher and visitor parking, and rooftop, all directly connected to a drainage system. The system outfall is hidden in the dense vegetation adjacent to the property and is undergoing significant erosion (Figure 2).

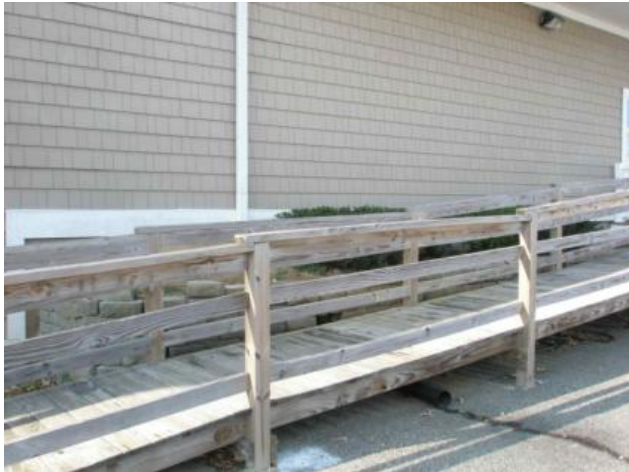
**Figure 1:** Left side of building downspout

**Description:** The Boys and Girls Club building on North Main Street is set in a large expanse of pavement that is shared with the adjacent property – more so than appears needed for parking demand (but it's unclear if the area is used temporarily for other purposes; Figure 3). There are two foundation planters in front of the building on either side of the front entrance: see Figure 1 and Figure 2 (planter in Figure 1 is partially hidden by the wooden ramp).

1) Redirect the downspouts located at each corner of the building into the foundation planters. The current downspout configuration includes piping to convey the roof water around, through, or under the planters (the downspout pipe is shown protruding from under the wooden ramp in Figure 1, and in Figure 2, it daylights where the two planter walls meet). This appears to be a very simple retrofit to redirect these downspouts into the existing planters. This type of practice is referred to as Urban Planters in the Virginia Stormwater BMP Design Specifications, primarily because they are suited for buildings in urban areas that may not have room for traditional bioretention.

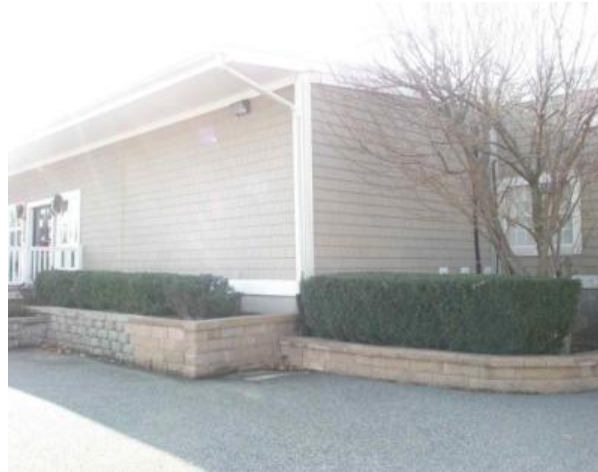
**Figure 1:** Right side downspout

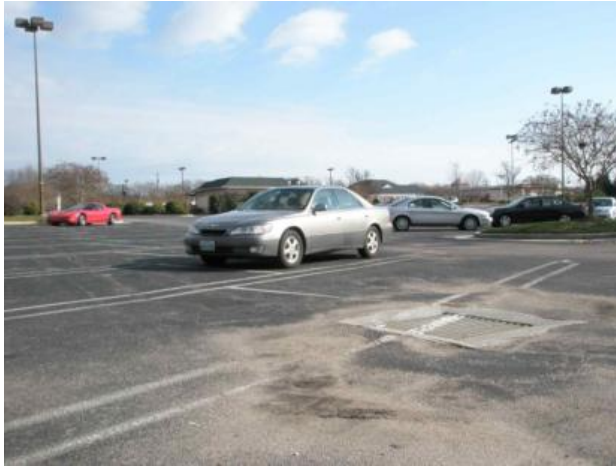
**Figure 1:** Typical parking lot inlet

**Description:** This shopping center has several tenants – Peebles appears to be the biggest. The entire front of the shopping center is a parking lot, approximately 3.6 acres, served by three drainage inlets. The shopping center rooftop is approximately 2 acres, and additional rooftop and parking for restaurants and a bank are located on the out parcels between the main parking lot and North Main Street (an additional 3 acres of impervious cover). There is also a large stormwater pond behind the shopping center. It is uncertain if this pond was designed to hold water (retention pond), or if it was intended to be a dry (extended detention) pond. In either case, there is evidence of erosion at one pipe outlet into the pond (the relatively small drainage from the rear loading dock) and sloughing on the side slopes in multiple locations. The combined effect of the internal erosion is the loss of storage volume (or pool volume if intended as a wet pond).

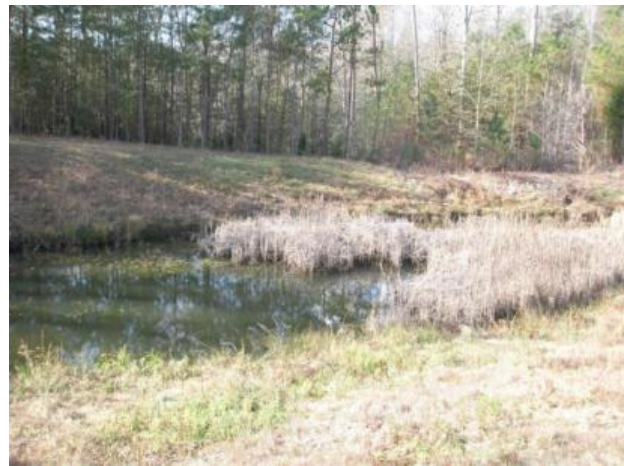
**Figure 1:** Stormwater basin behind shopping center

**Proposed Retrofits:** While the pond requires basic maintenance to fix the erosion, it appears to be functioning. A more rigorous analysis of the initial design and a survey of the current condition will verify if any dredging of the storage area is needed. Alternatively, installing bioretention retrofits in the front parking lot can possibly offset the loss in storage and provide an educational tool since it is a high traffic parking lot.

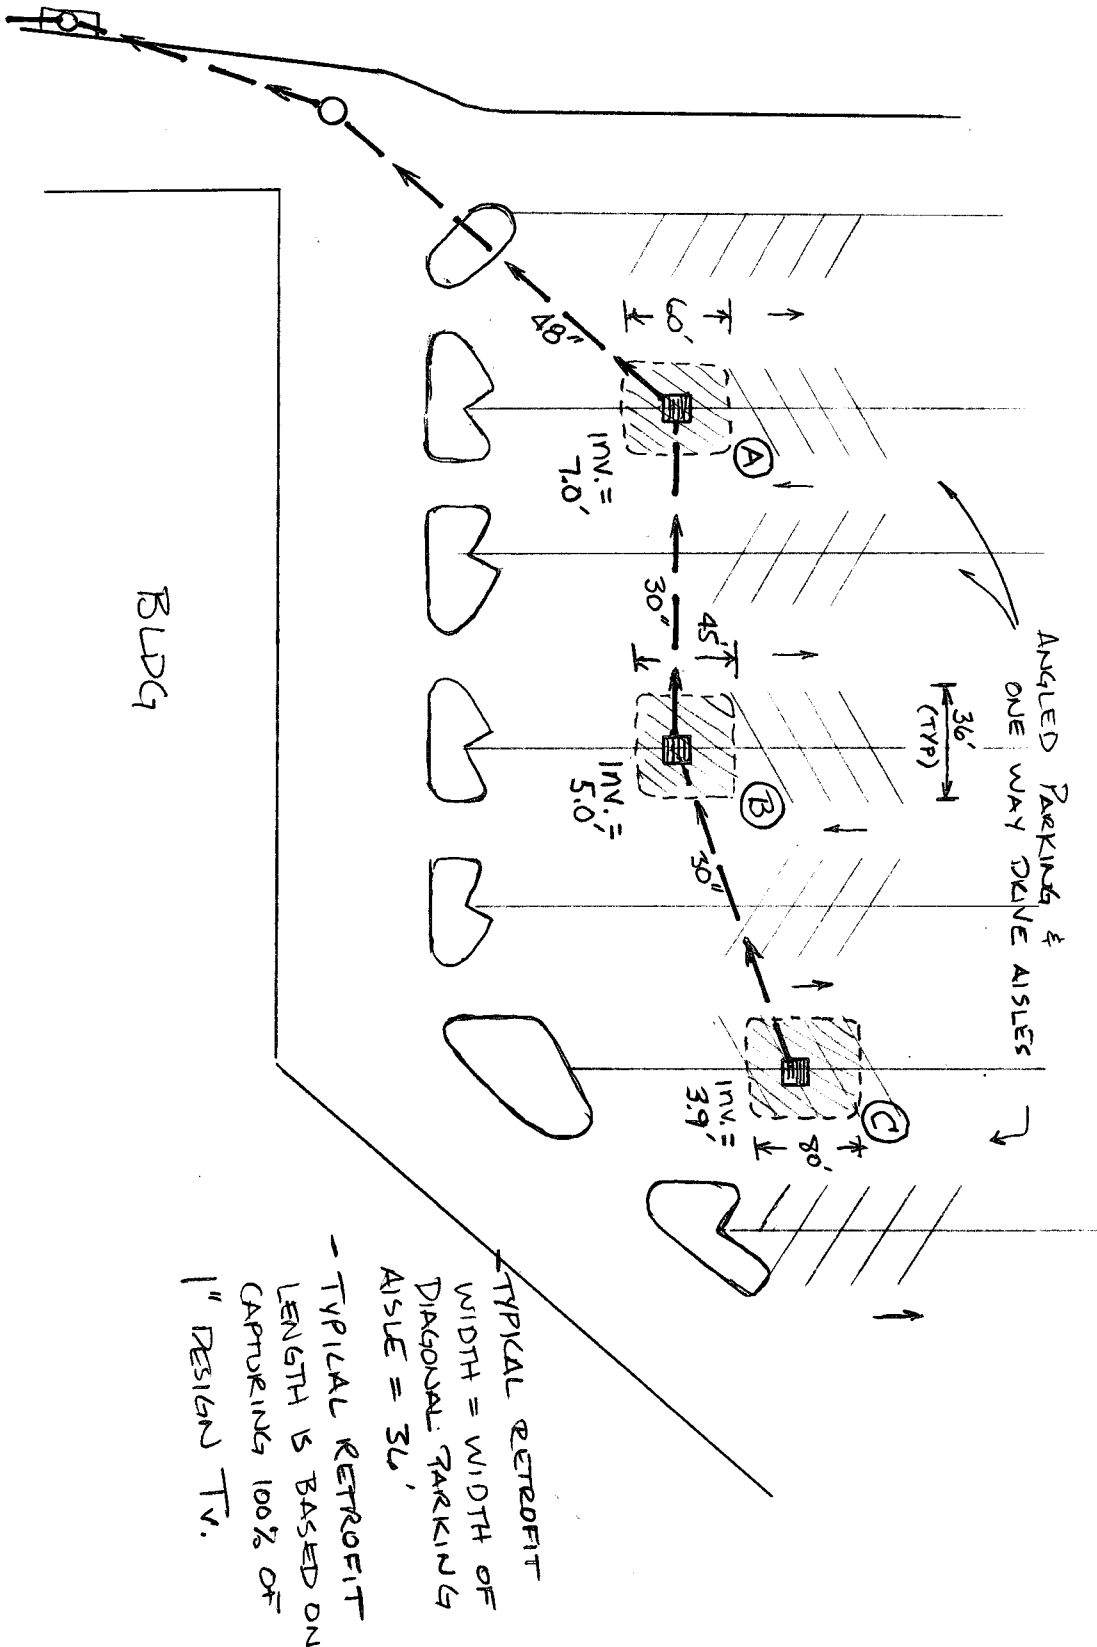
## SKETCH

Describe Existing Site Conditions, Including Existing Site Drainage and Conveyance:					
Existing Street Width: _____					
<u>LARGE PARKING LOT. EXISTING ISLANDS - NO IN LOW POINTS. 3 LARGE INLETS (DI-7) SPACED IN PARKING LOT.</u>					
Existing Head Available:			Note where points are measured from: (i.e. street elevation to catch basin invert, manhole rim to catch basin invert, other)		
<u>YES A = 7.0'</u> <u>B = 5.0'</u> <u>C = 3.9'</u>			<u>MEASURED FROM GRATE.</u>
